**Flood Control Project Maintenance  
Levee Inspections**

## 2019 Channel Summary Report

## Merced Streams Group

**Levee Inspection Report By Mile - Channel 2019**

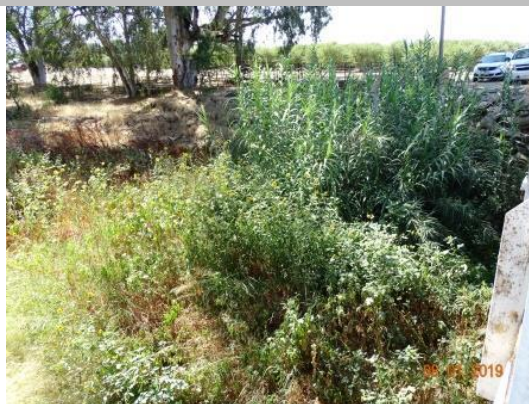
Photo 1 of 2 : CH\_2019\_NA0013\_35\_13\_20190809\_00106.jpg

Inspector Comments: Erosion along the left bank may affect the crossing in the future.

View of erosion along the left bank. Summer 2019

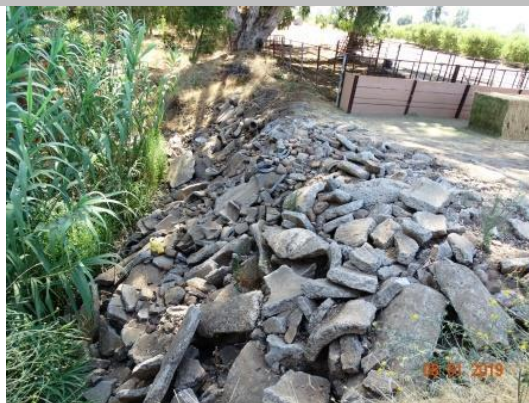
Photo 1 of 2 : CH\_2019\_NA0013\_35\_14\_20190809\_00107.jpg

View of the revetment on the left bank. Summer 2019

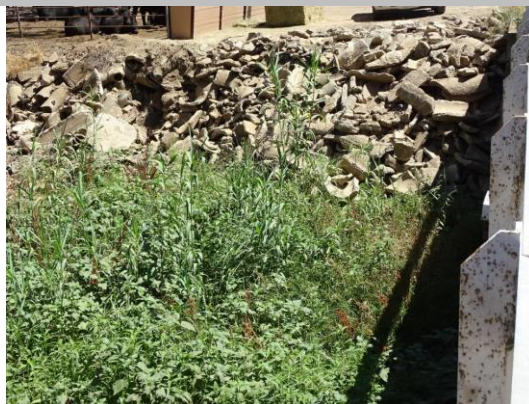
Photo 2 of 2 : CH\_2019\_NA0013\_35\_14\_20190722\_00008.jpg

View of the revetment on the left bank. Summer 2018

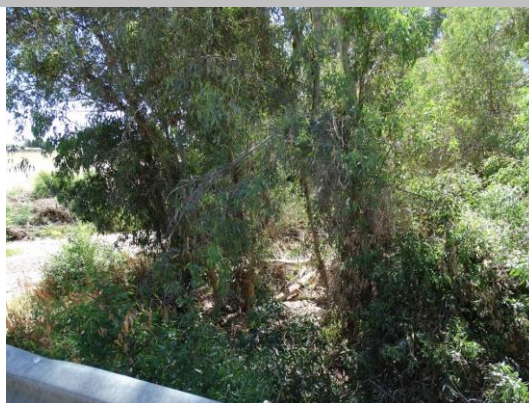
Photo 3 of 3 : CH\_2019\_NA0013\_35\_16\_20190722\_00011.jpg

Rating **	U	Issue No.	16	GPS Lat/Long
Issue Type +	Ma	Location *		37.237998 °
Category	Rivers, Channels & Designated Flood			-120.243649 °
Item	Vegetation & Obstructions			
DWR ID	DWR_NA0013_35_c_2016_16			
Action/Comments				
Inspector Comments: Excessive wild growth and woody vegetation may impede the channel capacity. Residents nearby claimed that vegetation caused flooding in past years.

View of vegetation along right bank. Summer 2018

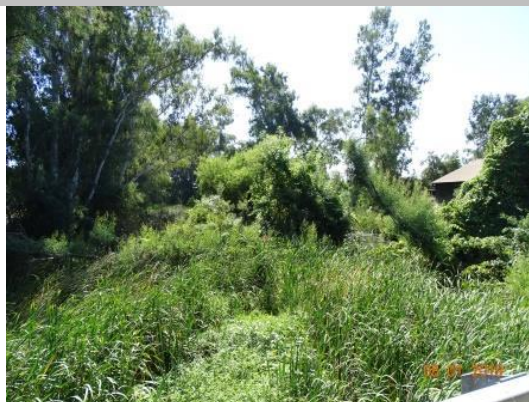
Photo 1 of 3 : CH\_2019\_NA0013\_35\_21\_20190809\_00100.jpg

Check Point / View				
Cunningham Rd / Up				
Rating **	U	Issue No.	21	GPS Lat/Long
Issue Type +	Ma	Location *		37.238920 °
Category	Rivers, Channels & Designated Flood			-120.252701 °
Item	Vegetation & Obstructions			
DWR ID	DWR_NA0013_35_c_2016_21			
Action/Comments				
Inspector Comments: Remove wild growth and fallen trees with ivy that may impede flows. Leaning tree may become a safety issue for adjacent property.

View of vegetation and fallen trees in the channel. Summer 2019

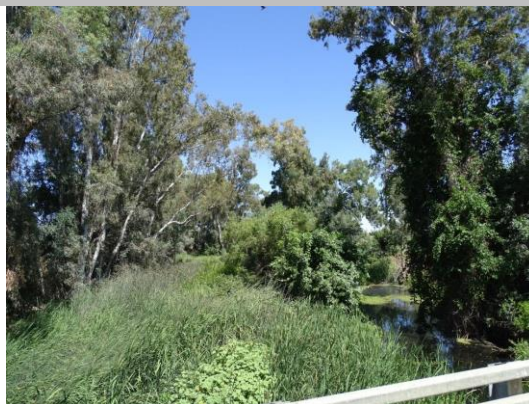
Photo 3 of 3 : CH\_2019\_NA0013\_35\_21\_20190722\_00014.jpg

Inspector Comments: Remove wild growth and fallen trees with ivy that may impede flows. Leaning tree may become a safety issue for adjacent property.

View of vegetation in the channel. Summer 2018

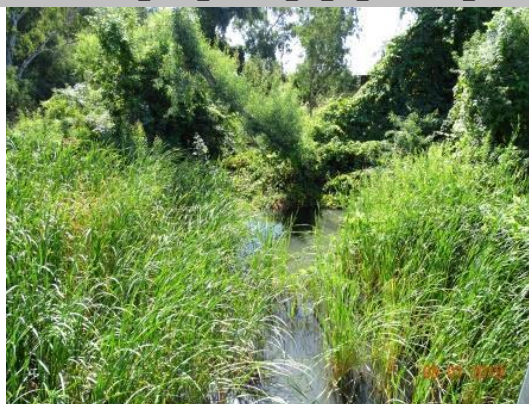
Photo 1 of 2 : CH\_2019\_NA0013\_35\_22\_20190809\_00101.jpg

Inspector Comments: Shoaling with vegetation may impede flow in the future and should be controlled.

View of shoaling with vegetation in the channel. Summer 2019

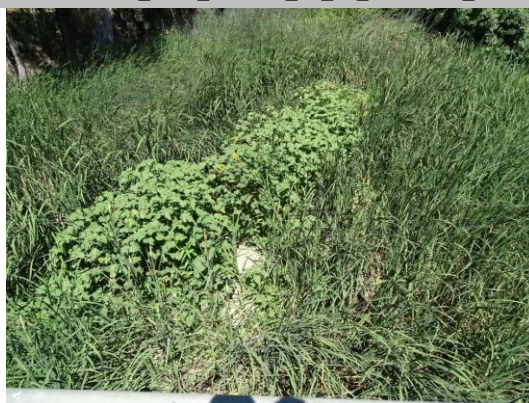
Photo 2 of 2 : CH\_2019\_NA0013\_35\_22\_20190722\_00017.jpg

Shoaling with vegetation in the channel. Summer 2018

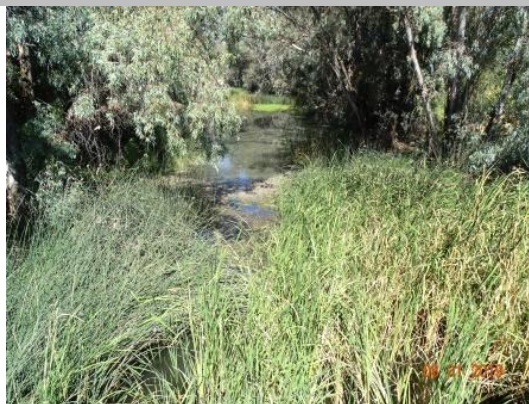
Photo 1 of 2 : CH\_2019\_NA0013\_35\_26\_20190809\_00104.jpg

View of vegetation in the channel. Summer 2019

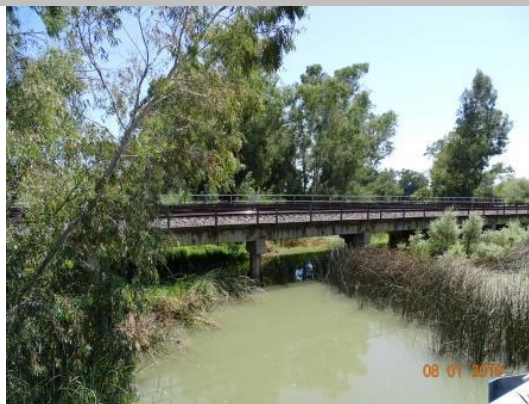
Photo 1 of 2 : CH\_2019\_NA0013\_35\_31\_20190812\_00110.jpg

Inspector Comments: Vegetation in the channel is growing and should be controlled.

View of vegetation in the channel. Summer 2019

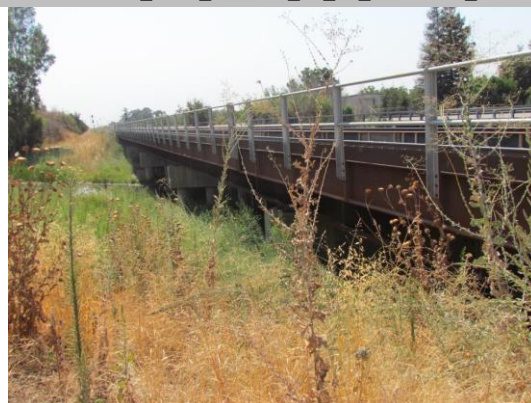
Photo 1 of 2 : CH\_2019\_NA0013\_35\_35\_20190722\_00025.jpg

Rating **	U	Issue No.	35	GPS Lat/Long
Issue Type +	En	Location *		37.239326 °
Category	Rivers, Channels & Designated Flood			-120.259357 °
Item	Encroachments			
DWR ID	DWR_NA0013_35_c_2016_35			
Action/Comments				
Inspector Comments: The new RR bridge crossing was not authorized by CVFPB, and BNSF needs to secure a permit.

View of the New RR Bridge line from upstream right bank.

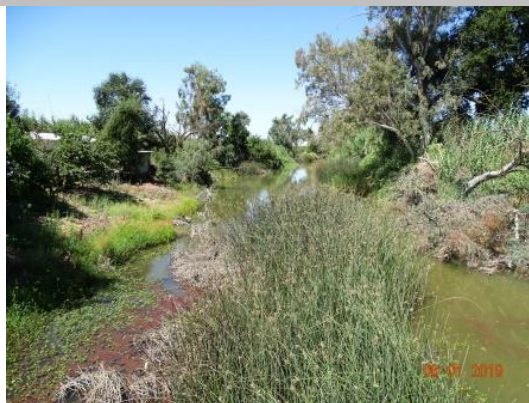
Photo 1 of 2 : CH\_2019\_NA0013\_35\_36\_20190812\_00111.jpg

Inspector Comments: The vegetation in the channel should be managed. Remove Arundo and fallen tree with exposed rootball from right bank.

View of vegetation in the channel. Summer 2019

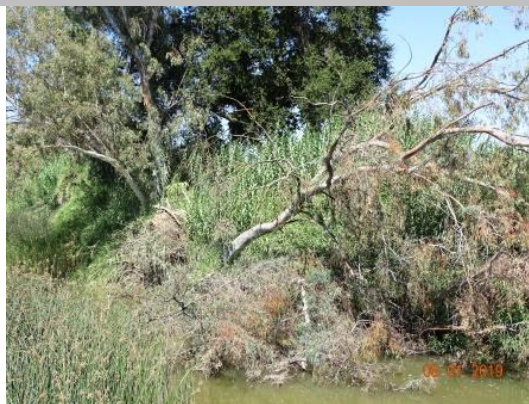
Photo 2 of 2 : CH\_2019\_NA0013\_35\_36\_20190813\_00112.jpg

Rating **	M	Issue No.	36 (cont)	GPS Lat/Long
Issue Type +	Ma	Location *		37.239326 °
Category	Rivers, Channels & Designated Flood			-120.259357 °
Item	Vegetation & Obstructions			
DWR ID	DWR_NA0013_35_c_2016_36			
Action/Comments				
Inspector Comments: The vegetation in the channel should be managed. Remove Arundo and fallen tree with exposed rootball from right bank.

View of fallen tree with exposed root ball on right bank. Summer 2019

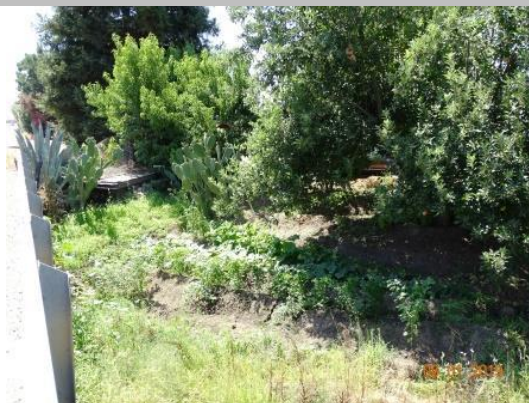
Photo 1 of 1 : CH\_2019\_NA0013\_35\_40\_20190813\_00113.jpg

Rating **	M	Issue No.	40	GPS Lat/Long
Issue Type +	En	Location *		37.239326 °
Category	Rivers, Channels & Designated Flood			-120.259357 °
Item	Encroachments			
DWR ID	DWR_NA0013_35_c_2016_40			
Action/Comments				
Inspector Comments: Property owner needs to remove cactus and garden from the left bank.

View of cactus and garden on the left bank. Summer 2019

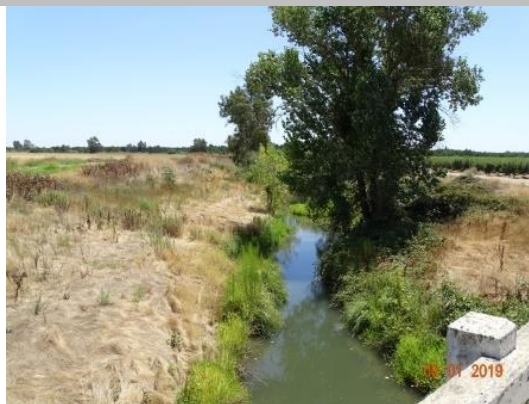
Photo 1 of 1 : CH\_2019\_NA0013\_35\_41\_20190813\_00114.jpg

View of vegetation in the channel. Summer 2019

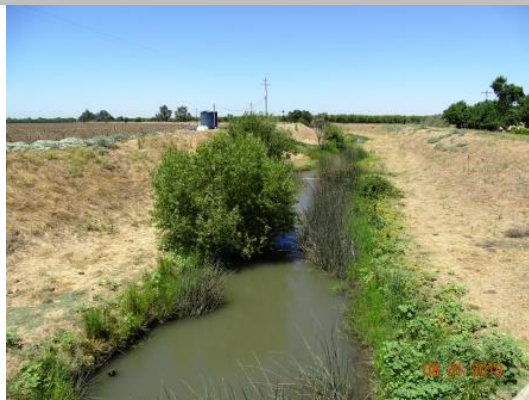
Photo 1 of 2 : CH\_2019\_NA0013\_35\_46\_20190813\_00115.jpg

View of vegetation downstream of Burchell Road. Summer 2019

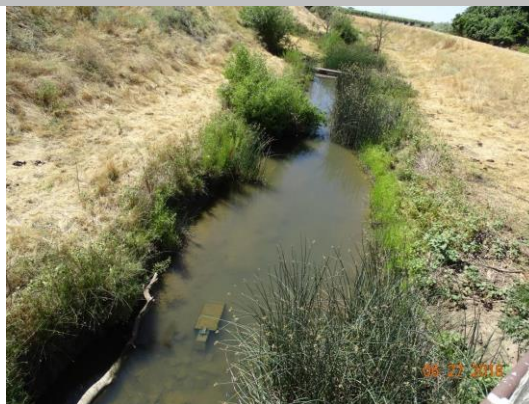
Photo 2 of 2 : CH\_2019\_NA0013\_35\_46\_20190722\_00030.jpg

View of vegetation in the channel and along banks. Summer 2018

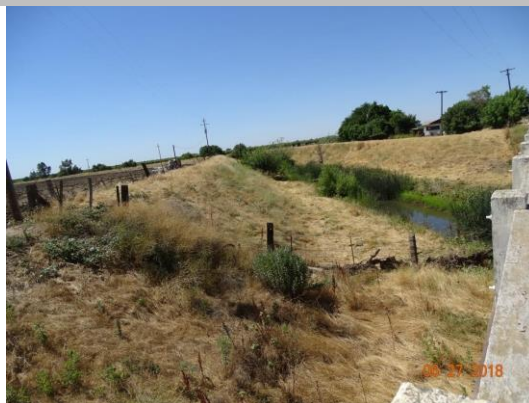
Photo 2 of 3 : CH\_2019\_NA0013\_35\_50\_20190722\_00032.jpg

View of wire fencing across left bank. Summer 2018

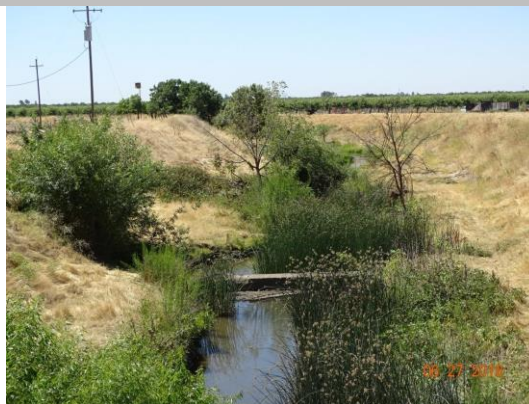
Photo 3 of 3 : CH\_2019\_NA0013\_35\_50\_20190722\_00033.jpg

Rating **	U	Issue No.	50 (cont)	GPS Lat/Long
Issue Type +	En	Location *		37.257235 °
Category	Rivers, Channels & Designated Flood			-120.288731 °
Item	Encroachments			
DWR ID	DWR_NA0013_35_c_2016_50			
Action/Comments				
Inspector Comments: A property line wire fence and a concrete weir exist across the channel without permits.

View of a concrete dam across channel. Summer 2018

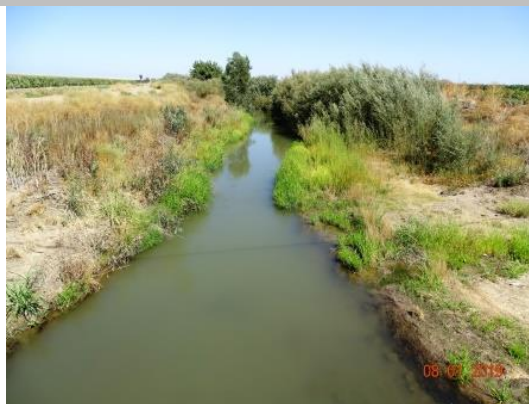
Photo 1 of 2 : CH\_2019\_NA0013\_35\_51\_20190814\_00117.jpg

View of vegetation along channel banks. Summer 2019

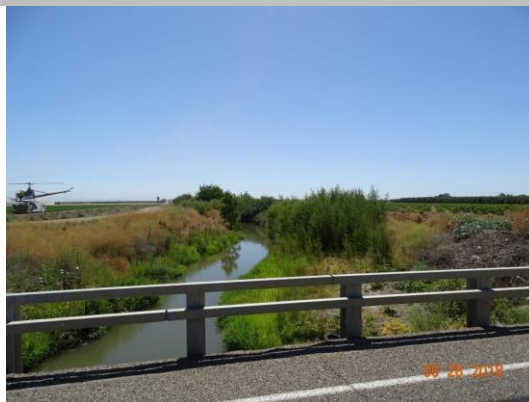
Photo 2 of 2 : CH\_2019\_NA0013\_35\_51\_20190722\_00037.jpg

View of vegetation along channel banks. Summer 2018

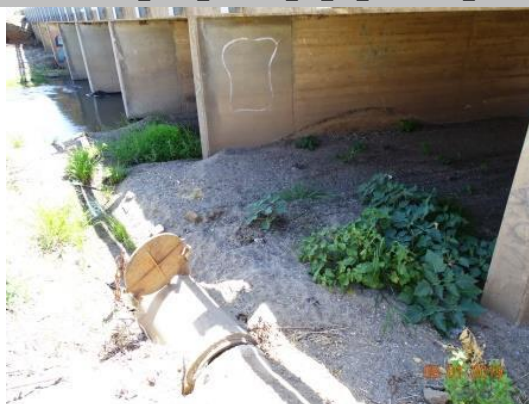
Photo 1 of 1 : CH\_2019\_NA0013\_35\_52\_20190814\_00120.jpg

Rating **	M	Issue No.	52	GPS Lat/Long
Issue Type +	Ma	Location *		37.258430 °
Category	Rivers, Channels & Designated Flood			-120.325070 °
Item	Shoaling / Sedimentation			
DWR ID	DWR_NA0013_35_c_2016_52			
Action/Comments				
Inspector Comments: Remove sedimentation in the two north bays of the bridge.

View of sedimentation in two north bays. Summer 2019

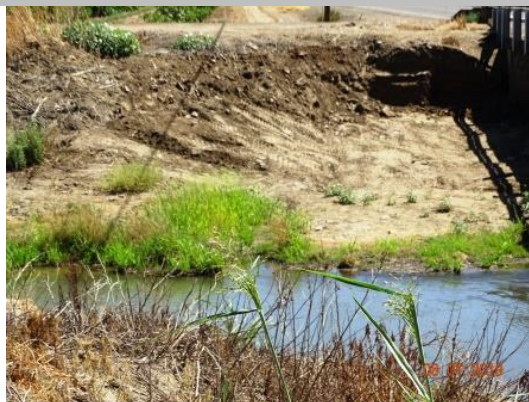
Photo 1 of 1 : CH\_2019\_NA0013\_35\_53\_20190814\_00119.jpg

Rating **	M	Issue No.	53	GPS Lat/Long
Issue Type +	Ma	Location *		37.258430 °
Category	Rivers, Channels & Designated Flood			-120.325070 °
Item	Erosion / Bank Caving			
DWR ID	DWR_NA0013_35_c_2016_53			
Action/Comments				
Inspector Comments: There is some erosion on the left bank that appears to be partially addressed by some fill.

View of left bank with erosion partially addressed with some fill.  
Summer 2019

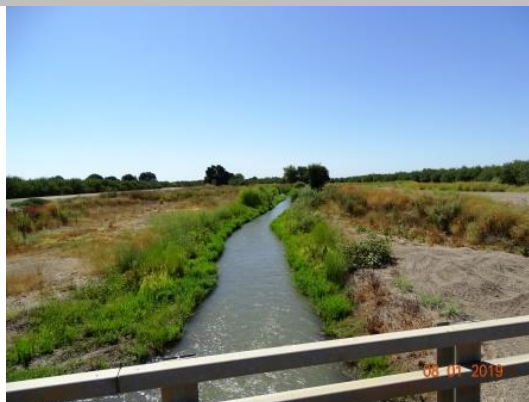
Photo 1 of 2 : CH\_2019\_NA0013\_35\_56\_20190814\_00121.jpg

View of vegetation in the channel. Summer 2019

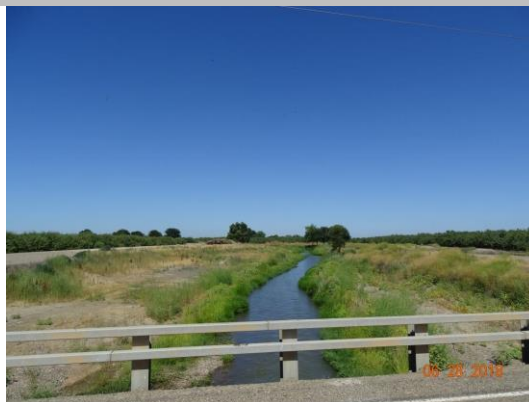
Photo 2 of 2 : CH\_2019\_NA0013\_35\_56\_20190722\_00041.jpg

View of vegetation along banks. Summer 2018

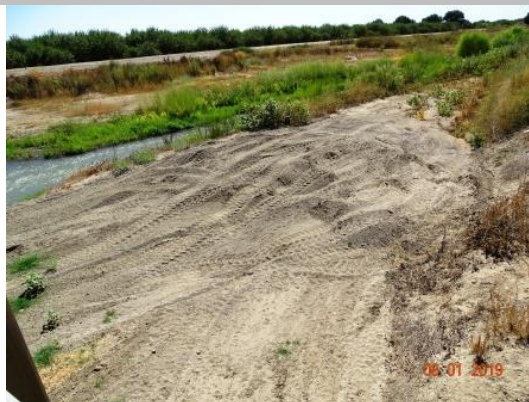
Photo 1 of 2 : CH\_2019\_NA0013\_35\_57\_20190814\_00122.jpg

Rating **	M	Issue No.	57	GPS Lat/Long
Issue Type +	Ma	Location *		37.258430 °
Category	Rivers, Channels & Designated Flood			-120.325070 °
Item	Shoaling / Sedimentation			
DWR ID	DWR_NA0013_35_c_2016_57			
Action/Comments				
Inspector Comments: There is sedimentation in the channel, but flow does not appear to be impeded.

View of shoaling with vegetation on left bank and sedimentation on right bank. Summer 2019

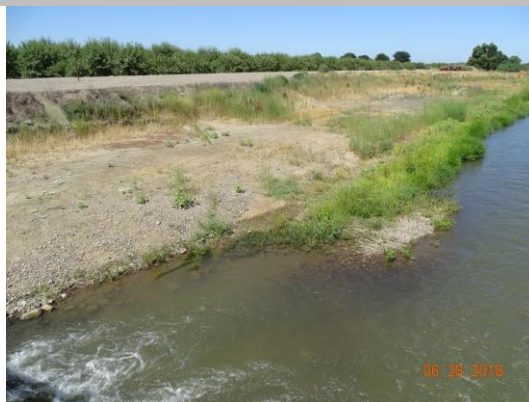
Photo 2 of 2 : CH\_2019\_NA0013\_35\_57\_20190722\_00043.jpg

View of sedimentation along the left bank. Summer 2018

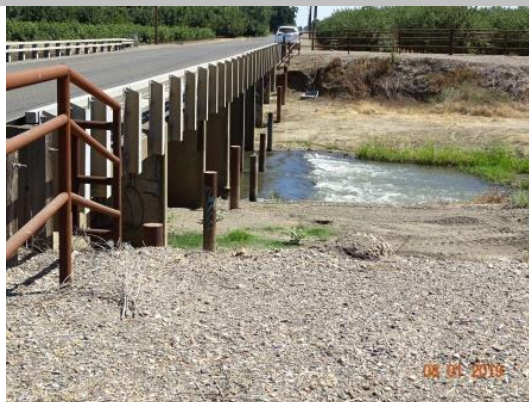
Photo 1 of 2 : CH\_2019\_NA0013\_35\_60\_20190814\_00124.jpg

Inspector Comments: There is no permit on file for these metal pipes crossing the Mariposa Creek.

View of metal railing and posts installed across channel. Summer 2019

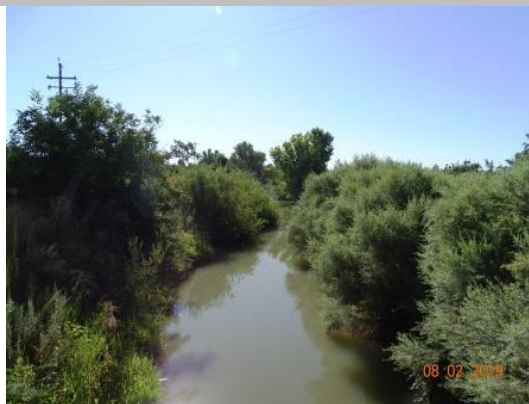
Photo 1 of 2 : CH\_2019\_NA0013\_35\_61\_20190814\_00125.jpg

Inspector Comments: Vegetation and possible beaver dam underneath crossing may impede flow.

View of vegetation along the banks. Summer 2019

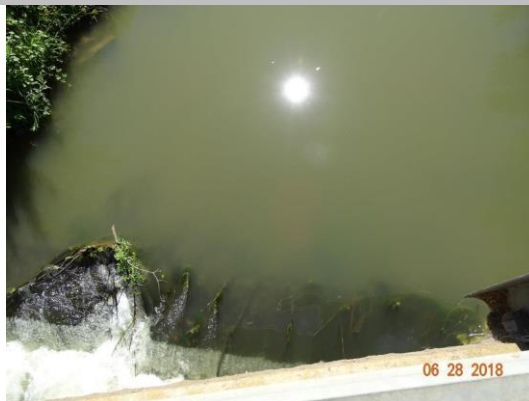
Photo 1 of 1 : CH\_2019\_NA0013\_35\_65\_20190722\_00052.jpg

Rating **	M	Issue No.	65	GPS Lat/Long
Issue Type +	En	Location *		37.261540 °
Category	Rivers, Channels & Designated Flood			-120.343200 °
Item	Encroachments			
DWR ID	DWR_NA0013_35_c_2016_65			
Action/Comments				
Inspector Comments: This concrete weir structure does not appear to have a permit.

View of a concrete weir underneath the crossing. Summer 2018

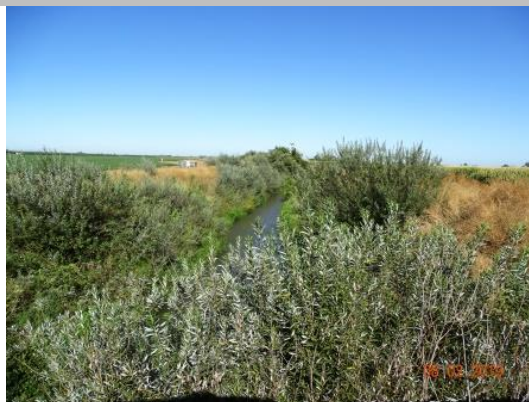
Photo 1 of 2 : CH\_2019\_NA0013\_35\_66\_20190814\_00127.jpg

Rating **	M	Issue No.	66	GPS Lat/Long
Issue Type +	Ma	Location *		37.261540 °
Category	Rivers, Channels & Designated Flood			-120.343200 °
Item	Vegetation & Obstructions			
DWR ID	DWR_NA0013_35_c_2016_66			
Action/Comments				
Inspector Comments: Remove woody vegetation in the channel.

View of vegetation along the banks. Summer 2019

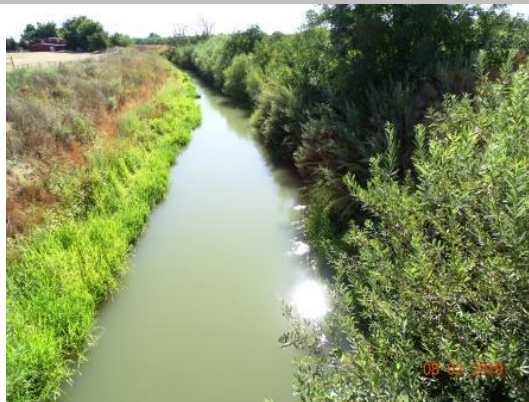
Photo 1 of 2 : CH\_2019\_NA0013\_35\_71\_20190814\_00128.jpg

Rating **	M	Issue No.	71	GPS Lat/Long
Issue Type +	Ma	Location *		37.257036 °
Category	Rivers, Channels & Designated Flood			-120.379219 °
Item	Vegetation & Obstructions			
DWR ID	DWR_NA0013_35_c_2016_71			
Action/Comments				
Inspector Comments: Control the vegetation growth on the left bank.

View of vegetation along banks. Summer 2019

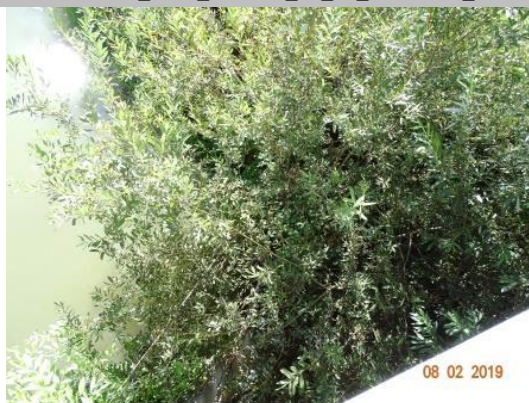
Photo 2 of 2 : CH\_2019\_NA0013\_35\_71\_20190814\_00129.jpg

View of vegetation along left bank. Summer 2019

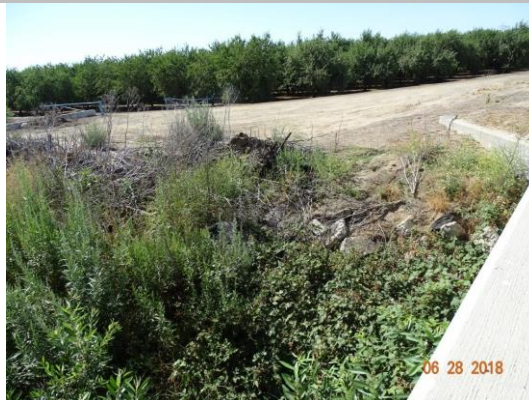
Photo 1 of 2 : CH\_2019\_NA0013\_35\_74\_20190722\_00059.jpg

Rating **	A	Issue No.	74	GPS Lat/Long
Issue Type +	Ma	Location *		37.257036 °
Category	Rivers, Channels & Designated Flood			-120.379219 °
Item	Revetments			
DWR ID	DWR_NA0013_35_c_2016_74			
Action/Comments				
Inspector Comments: Revetment consists of broken concrete and is visible on both banks.

View of left bank riprap. Summer 2018

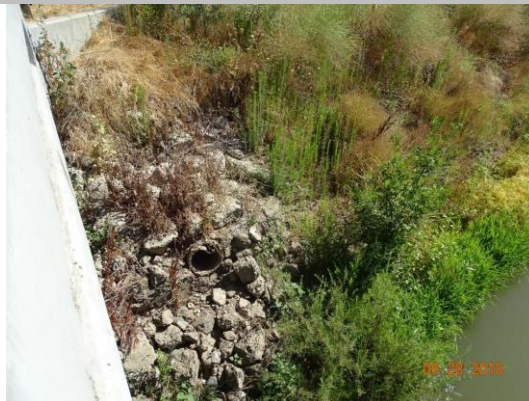
Photo 2 of 2 : CH\_2019\_NA0013\_35\_74\_20190722\_00060.jpg

View of right bank riprap. Summer 2018

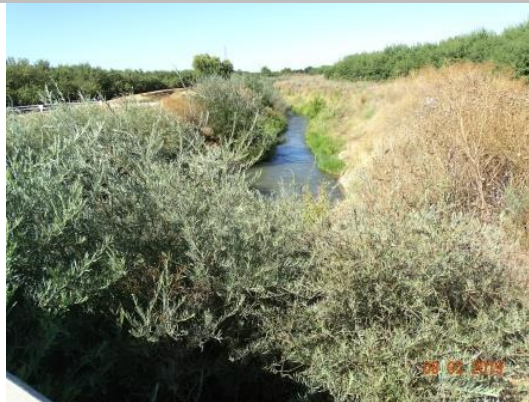
Photo 1 of 2 : CH\_2019\_NA0013\_35\_76\_20190814\_00130.jpg

Check Point / View				
Arboleda Rd / Down				
Rating **	M	Issue No.	76	GPS Lat/Long
Issue Type +	Ma	Location *		37.257036 °
Category	Rivers, Channels & Designated Flood			-120.379219 °
Item	Vegetation & Obstructions			
DWR ID	DWR_NA0013_35_c_2016_76			
Action/Comments				
Inspector Comments: Remove woody vegetation from the channel.

View of vegetation in the channel and along the banks. Summer 2019

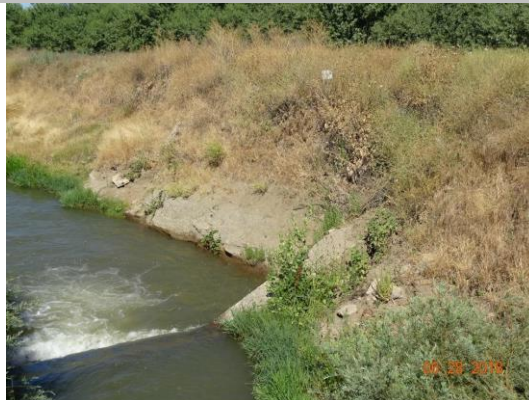
Photo 2 of 4 : CH\_2019\_NA0013\_35\_78\_20190722\_00065.jpg

Rating **	U	Issue No.	78	GPS Lat/Long
Issue Type +	Ma	Location *		37.256910 °
Category	Rivers, Channels & Designated Flood			-120.379490 °
Item	Erosion / Bank Caving			
DWR ID	DWR_NA0013_35_c_2016_78			
Action/Comments				
Inspector Comments: Repairs are needed at the erosion site on the right bank.

View of erosion on the right bank. Summer 2018

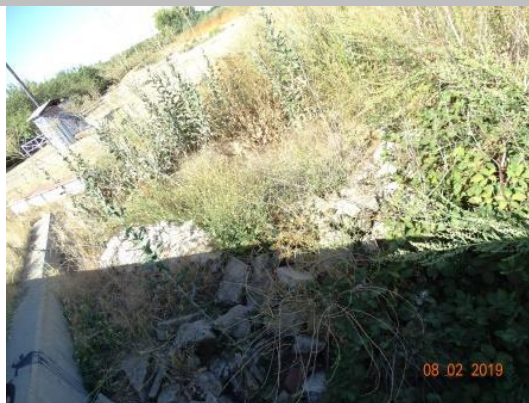
Photo 1 of 2 : CH\_2019\_NA0013\_35\_79\_20190814\_00132.jpg

View of riprap on the left bank. Summer 2019

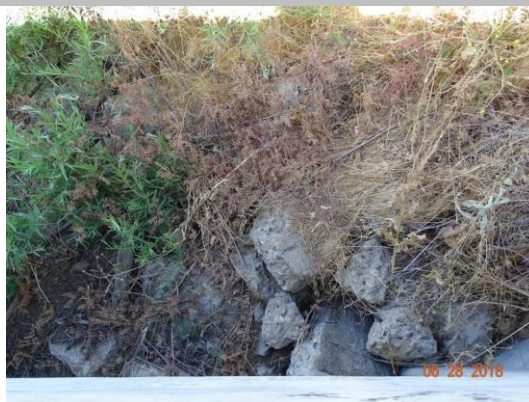
Photo 2 of 2 : CH\_2019\_NA0013\_35\_79\_20190722\_00070.jpg

View of riprap on right bank. Summer 2018

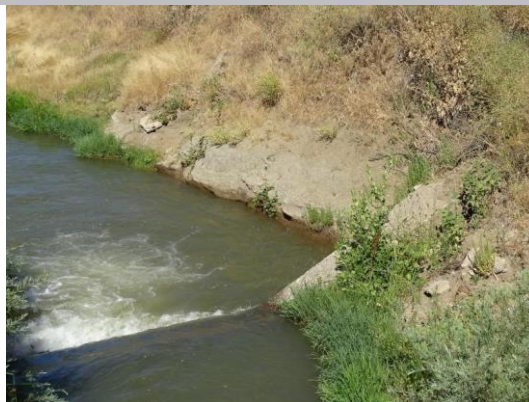
Photo 1 of 1 : CH\_2019\_NA0013\_35\_80\_20190722\_00071.jpg

Rating **	U	Issue No.	80	GPS Lat/Long
Issue Type +	En	Location *		37.257036 °
Category	Rivers, Channels & Designated Flood			-120.379219 °
Item	Encroachments			
DWR ID	DWR_NA0013_35_c_2016_80			
Action/Comments				
Inspector Comments: A longstanding concrete weir structure exists across the channel without an apparent permit.

View of a longstanding concrete weir structure across the channel.  
Summer 2018

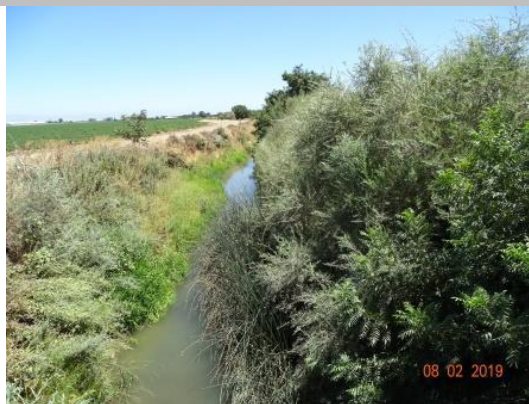
Photo 1 of 1 : CH\_2019\_NA0013\_35\_81\_20190814\_00136.jpg

Rating **	M	Issue No.	81	GPS Lat/Long
Issue Type +	Ma	Location *		37.246003 °
Category	Rivers, Channels & Designated Flood			-120.434235 °
Item	Vegetation & Obstructions			
DWR ID	DWR_NA0013_35_c_2016_81			
Action/Comments				
Inspector Comments: Control the wild growth on both banks, and remove debris from underneath the crossing.

View of vegetation along banks. Summer 2019

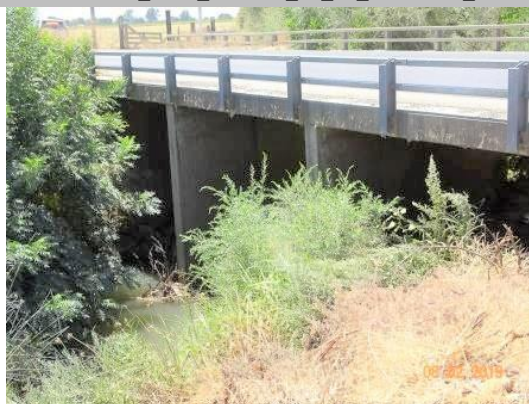
Photo 1 of 2 : CH\_2019\_NA0013\_35\_82\_20190814\_00138.jpg

Rating **	M	Issue No.	82	GPS Lat/Long
Issue Type +	Ma	Location *		37.246003 °
Category	Rivers, Channels & Designated Flood			-120.434235 °
Item	Shoaling / Sedimentation			
DWR ID	DWR_NA0013_35_c_2016_82			
Action/Comments				
Inspector Comments: Sedimentation in the northernmost bay of the bridge is diverting flows to the south bays.

View of sedimentation in the northernmost bay. Summer 2019

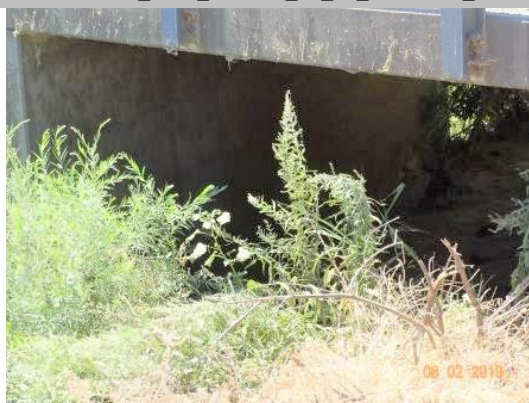
Photo 2 of 2 : CH\_2019\_NA0013\_35\_82\_20190814\_00137.jpg

View of sedimentation in the northernmost bay. Summer 2019

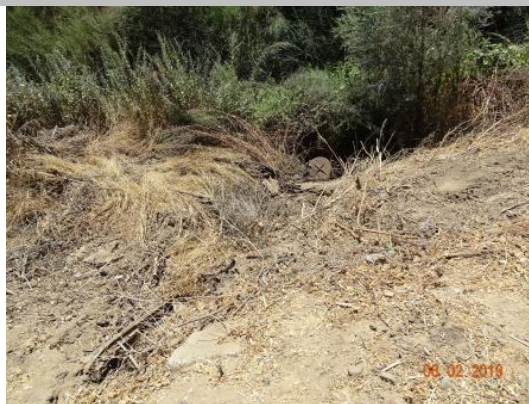
Photo 1 of 1 : CH\_2019\_NA0013\_35\_83\_20190814\_00139.jpg

Inspector Comments: Erosion around the drainage outlet is cutting into the cross section.

View of erosion near the drainage outlet on the right bank. Summer

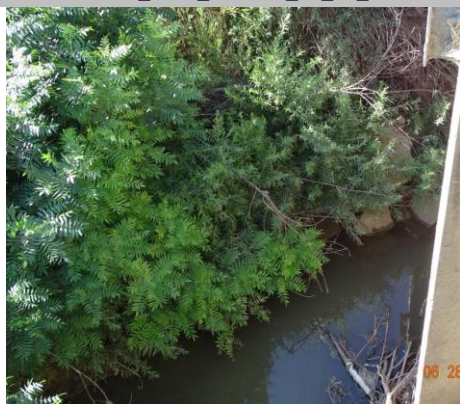
Photo 1 of 1 : CH\_2019\_NA0013\_35\_84\_20190722\_00075.jpg

Inspector Comments: Unwanted vegetation over riprap must be cleared.

View of revetment covered by vegetation on the left bank. Summer 2018

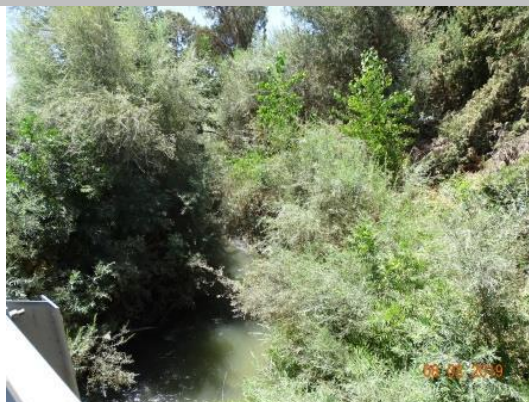
Photo 1 of 2 : CH\_2019\_NA0013\_35\_86\_20190814\_00140.jpg

Inspector Comments: Control the wild vegetation growth on both banks of the channel, which is impeding flows.

View of vegetation in the channel and along the banks. Summer 2019

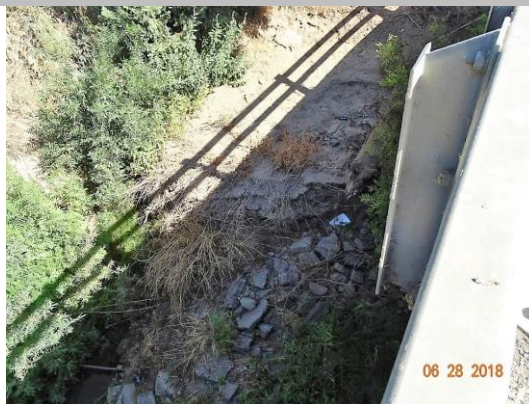
Photo 1 of 2 : CH\_2019\_NA0013\_35\_88\_20190722\_00078.jpg

Inspector Comments: Erosion near the crossing on both banks may affect infrastructure in the future.

View of erosion on the right bank. Summer 2018

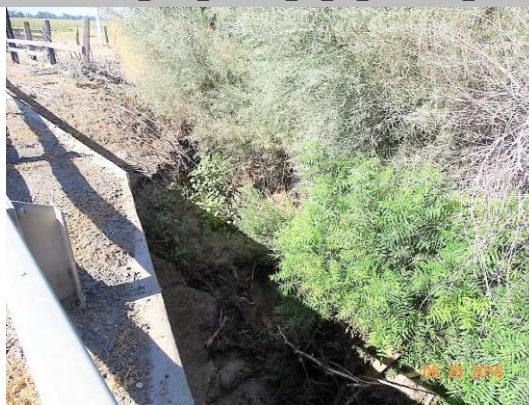
Photo 2 of 2 : CH\_2019\_NA0013\_35\_88\_20190722\_00079.jpg

View of erosion on the left bank. Summer 2018

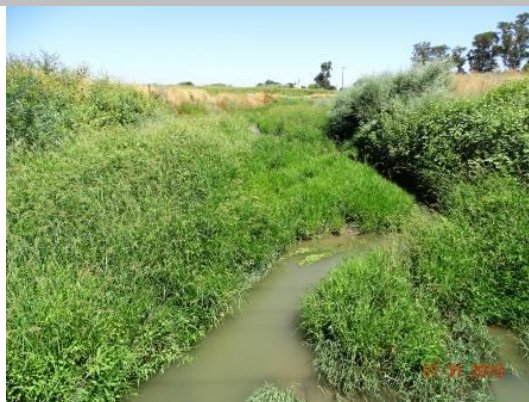
Photo 1 of 2 : CH\_2019\_NA0013\_35\_91\_20190809\_00093.jpg

Inspector Comments: Remove woody vegetation from the channel.

View of vegetation in the channel upstream of Hwy 59. Summer 2019

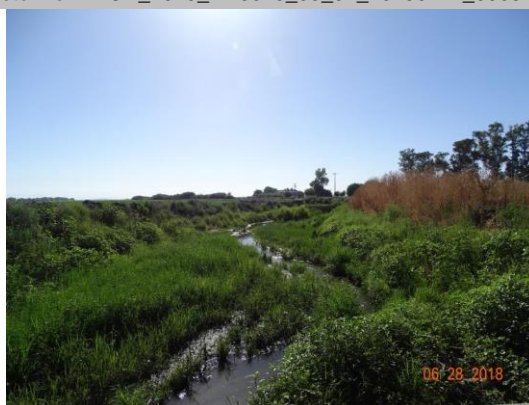
Photo 2 of 2 : CH\_2019\_NA0013\_35\_91\_20190722\_00082.jpg

View of vegetation in the channel and along banks. Summer 2018

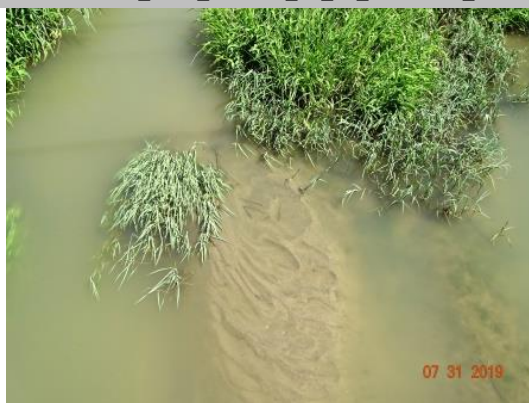
Photo 1 of 2 : CH\_2019\_NA0013\_35\_92\_20190809\_00094.jpg

Inspector Comments: Non-aquatic grasses are present on shoal but do not appear to impede flow at this time.

View of shoaling with vegetation in the channel. Summer 2019

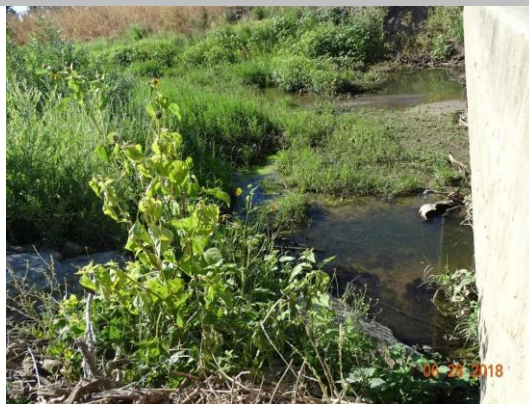
Photo 2 of 2 : CH\_2019\_NA0013\_35\_92\_20190722\_00084.jpg

Check Point / View				
Hwy 59 / Up (cont)				
Rating **	M	Issue No.	92 (cont)	GPS Lat/Long
Issue Type +	Ma	Location *		37.233949 °
Category	Rivers, Channels & Designated Flood			-120.488009 °
Item	Shoaling / Sedimentation			
DWR ID	DWR_NA0013_35_c_2016_92			
Action/Comments				
Inspector Comments: Non-aquatic grasses are present on shoal but do not appear to impede flow at this time.

View of shoal with vegetation. Summer 2018

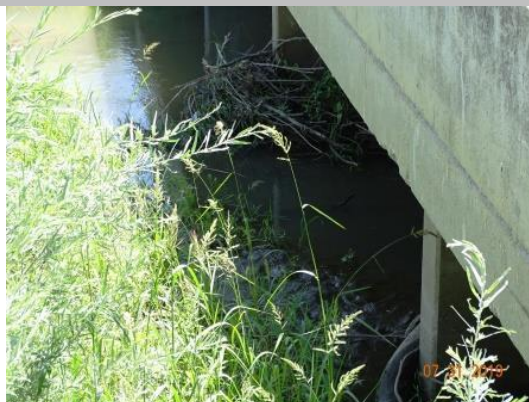
Photo 1 of 1 : CH\_2019\_NA0013\_35\_95\_20190809\_00095.jpg

Rating **	M	Issue No.	95	GPS Lat/Long
Issue Type +	Ma	Location *		37.233949 °
Category	Rivers, Channels & Designated Flood			-120.488009 °
Item	Encroachments			
DWR ID	DWR_NA0013_35_c_2016_95			
Action/Comments				
Inspector Comments: Remove debris from the upstream side of the bridge.

View of debris at upstream side of Hwy 59 crossing. Summer 2019

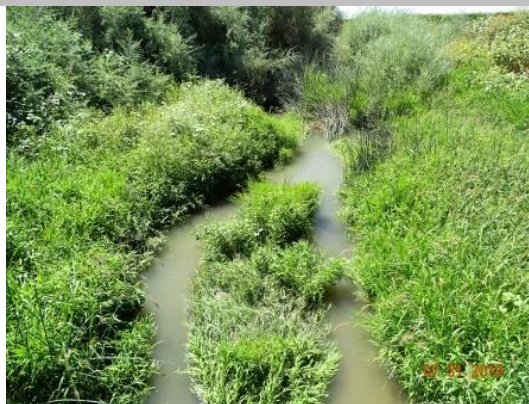
Photo 1 of 2 : CH\_2019\_NA0013\_35\_96\_20190809\_00096.jpg

Rating **	U	Issue No.	96	GPS Lat/Long
Issue Type +	Ma	Location *		37.233949 °
Category	Rivers, Channels & Designated Flood			-120.488009 °
Item	Vegetation & Obstructions			
DWR ID	DWR_NA0013_35_c_2016_96			
Action/Comments				
Inspector Comments: The wild growth on both banks will likely impede flow and needs to be controlled.

View of vegetation downstream of the Hwy 59 crossing. Summer 2019

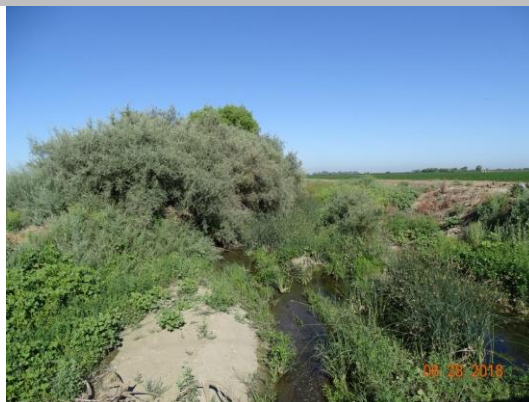
Photo 2 of 2 : CH\_2019\_NA0013\_35\_96\_20190722\_00088.jpg

Rating **	U	Issue No.	96 (cont)	GPS Lat/Long
Issue Type +	Ma	Location *		37.233949 °
Category	Rivers, Channels & Designated Flood			-120.488009 °
Item	Vegetation & Obstructions			
DWR ID	DWR_NA0013_35_c _ 2016_96			
Action/Comments				
Inspector Comments: The wild growth on both banks will likely impede flow and needs to be controlled.

View of vegetation in channel and along banks. Summer 2018

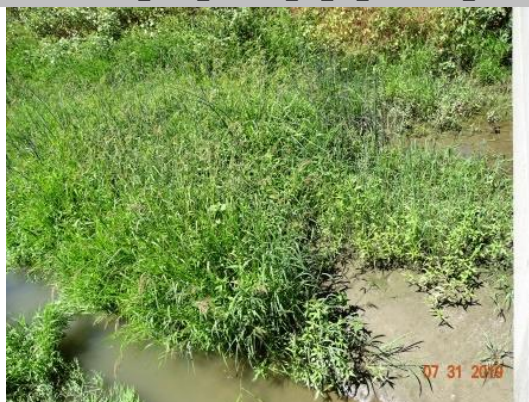
Photo 1 of 2 : CH\_2019\_NA0013\_35\_97\_20190809\_00097.jpg

Rating **	M	Issue No.	97	GPS Lat/Long
Issue Type +	Ma	Location *		37.233949 °
Category	Rivers, Channels & Designated Flood			-120.488009 °
Item	Shoaling / Sedimentation			
DWR ID	DWR_NA0013_35_c_2016_97			
Action/Comments				
Inspector Comments: Non-aquatic grasses are present on the shoal.

View of the shoal downstream of Hwy 59 crossing. Summer 2019

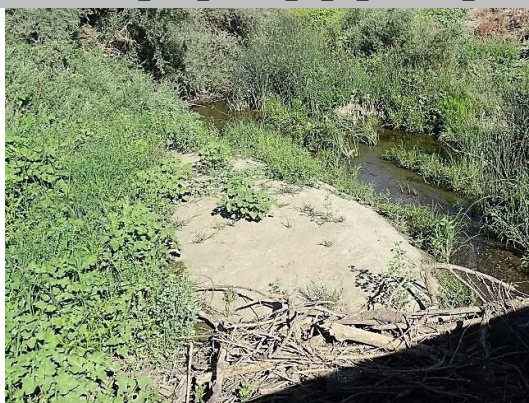
Photo 2 of 2 : CH\_2019\_NA0013\_35\_97\_20190722\_00090.jpg

View of the shoal in the channel. Summer 2018

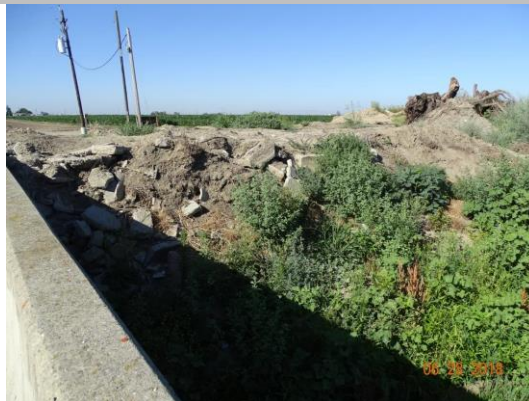
Photo 2 of 2 : CH\_2019\_NA0013\_35\_99\_20190722\_00092.jpg

View of revetment on left bank. Summer 2018

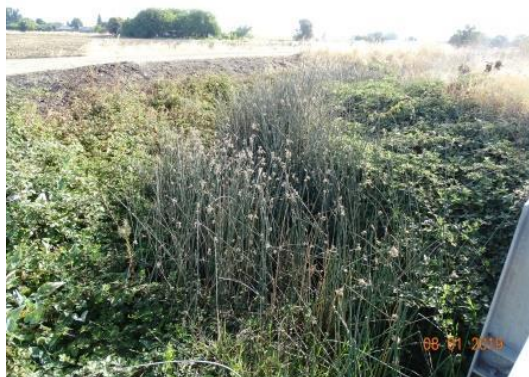
Photo 1 of 2 : CH\_2019\_NA0013\_36\_1\_20190809\_00077.jpg

View of vegetation in the channel. Summer 2019

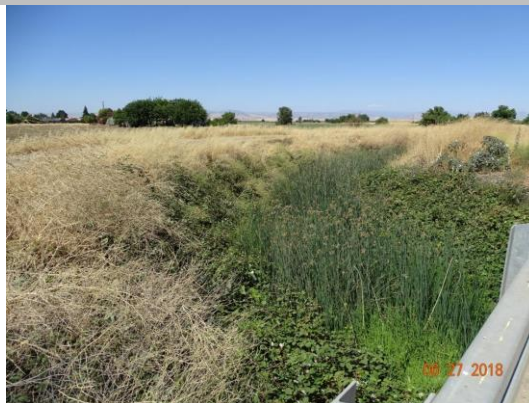
Photo 2 of 2 : CH\_2019\_NA0013\_36\_1\_20190722\_00001.jpg

View of vegetation in the channel. Summer 2018

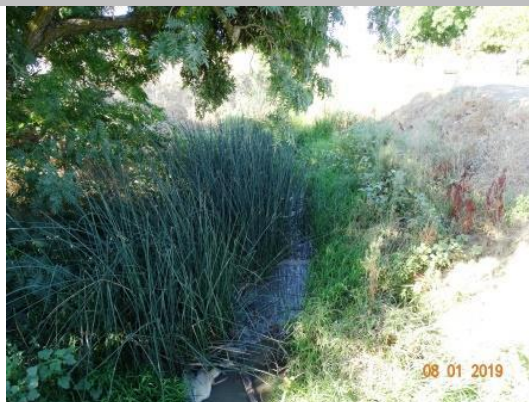
Photo 1 of 2 : CH\_2019\_NA0013\_36\_6\_20190809\_00078.jpg

View of vegetation in the channel. Summer 2019

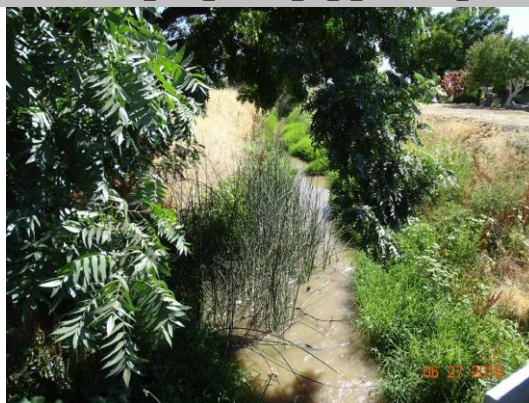
Photo 2 of 2 : CH\_2019\_NA0013\_36\_6\_20190722\_00003.jpg

Rating **	A	Issue No.	6 (cont)	GPS Lat/Long
Issue Type +	Ma	Location *		37.287962 °
Category	Rivers, Channels & Designated Flood			-120.309170 °
Item	Vegetation & Obstructions			
DWR ID	DWR_NA0013_36_c_2012_6			
Action/Comments

View of vegetation in the channel. Summer 2018

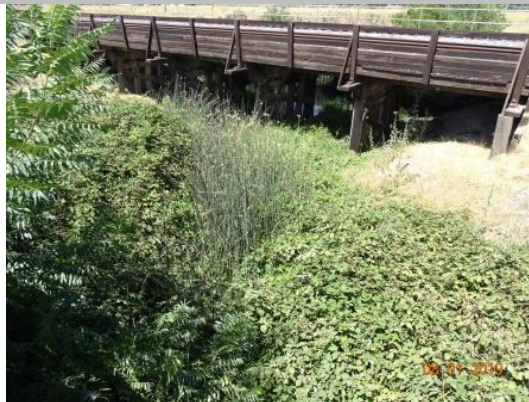
Photo 1 of 2 : CH\_2019\_NA0013\_36\_11\_20190813\_00079.jpg

Inspector Comments: Blackberry and a few trees are growing near the bridge which may impede flow; vegetation and driftwood need to be cleared.

View of vegetation in the channel. Summer 2019

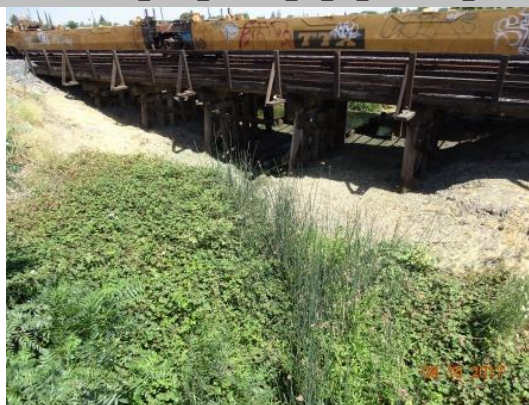
Photo 2 of 2 : CH\_2019\_NA0013\_36\_11\_20190722\_00007.jpg

Rating **	M	Issue No.	11 (cont)	GPS Lat/Long
Issue Type +	Ma	Location *		37.284356 °
Category	Rivers, Channels & Designated Flood			-120.315478 °
Item	Vegetation & Obstructions			
DWR ID	DWR_NA0013_36_c_2012_11

View from the Santa Fe Dr. crossing looking upstream. Summer 2017

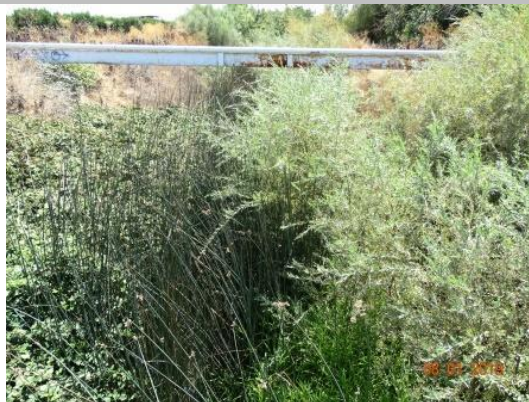
Photo 1 of 2 : CH\_2019\_NA0013\_36\_16\_20190813\_00080.jpg

Inspector Comments: Woody vegetation may impede flow in the future and should be cleared at least 100 feet downstream.

View of vegetation in the channel. Summer 2019

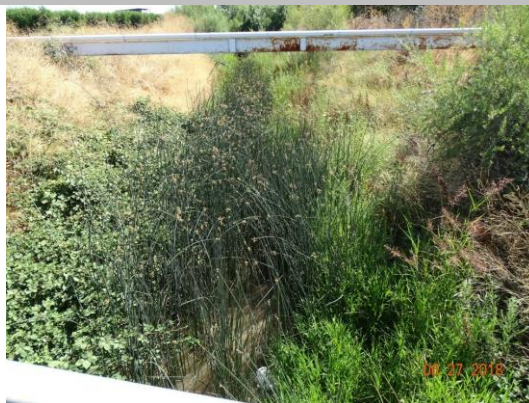
Photo 2 of 2 : CH\_2019\_NA0013\_36\_16\_20190722\_00008.jpg

Rating **	M	Issue No.	<b>16 (cont)</b>	GPS Lat/Long
Issue Type +	Ma	Location *		37.284393 °
Category	Rivers, Channels & Designated Flood			-120.315460 °
Item	Vegetation & Obstructions			
DWR ID	DWR_NA0013_36_c_2012_16

View of vegetation in the channel. Summer 2018

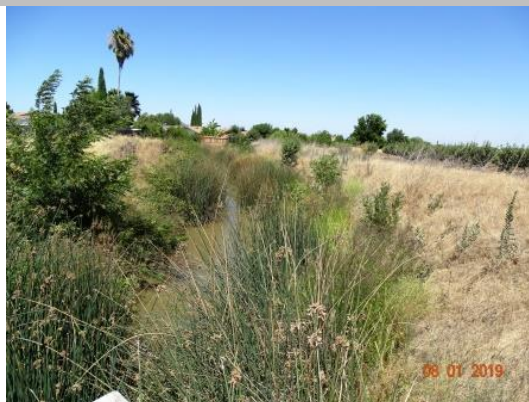
Photo 1 of 2 : CH\_2019\_NA0013\_36\_21\_20190814\_00081.jpg

Rating **	A	Issue No.	21	GPS Lat/Long
Issue Type +	Ma	Location *		37.282285 °
Category	Rivers, Channels & Designated Flood			-120.324890 °
Item	Vegetation & Obstructions			
DWR ID	DWR_NA0013_36_c_2012_21			
Action/Comments

View of vegetation in the channel. Summer 2019

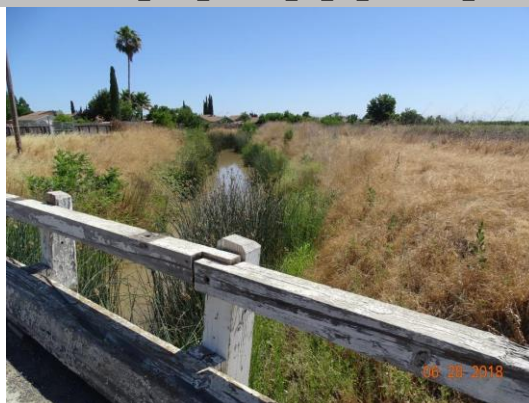
Photo 2 of 2 : CH\_2019\_NA0013\_36\_21\_20190722\_00011.jpg

Rating **	A	Issue No.	21 (cont)	GPS Lat/Long
Issue Type +	Ma	Location *		37.282285 °
Category	Rivers, Channels & Designated Flood			-120.324890 °
Item	Vegetation & Obstructions			
DWR ID	DWR_NA0013_36_c_2012_21			
Action/Comments

View of vegetation in the channel. Summer 2018

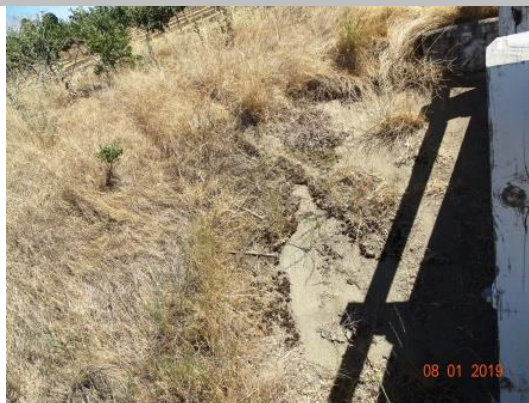
Photo 1 of 1 : CH\_2019\_NA0013\_36\_24\_20190814\_00083.jpg

Rating **	N	Issue No.	24	GPS Lat/Long
Issue Type +	Ma	Location *		37.282285 °
Category	Rivers, Channels & Designated Flood			-120.324890 °
Item	Revetments			
DWR ID	DWR_NA0013_36_c_2012_24			
Action/Comments				
Inspector Comments: The channel is concrete-lined at the bridge.

View of concrete-lined channel section under the bridge. Summer 2019

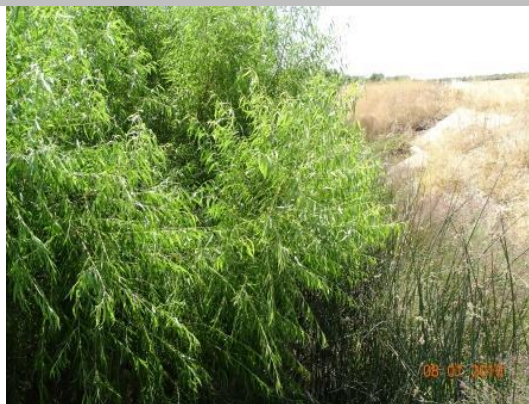
Photo 1 of 2 : CH\_2019\_NA0013\_36\_26\_20190814\_00084.jpg

Rating **	M	Issue No.	26	GPS Lat/Long
Issue Type +	Ma	Location *		37.282060 °
Category	Rivers, Channels & Designated Flood			-120.324870 °
Item	Vegetation & Obstructions			
DWR ID	DWR_NA0013_36_c_2012_26			
Action/Comments				
Inspector Comments: Woody vegetation in the channel should be maintained to prevent a reduction in channel capacity.

View of vegetation in the channel. Summer 2019

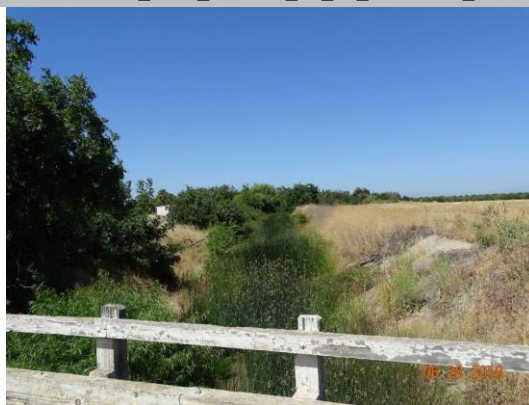
Photo 2 of 2 : CH\_2019\_NA0013\_36\_26\_20190722\_00013.jpg

Rating **	M	Issue No.	<b>26 (cont)</b>	GPS Lat/Long
Issue Type +	Ma	Location *		37.282060 °
Category	Rivers, Channels & Designated Flood			-120.324870 °
Item	Vegetation & Obstructions			
DWR ID	DWR_NA0013_36_c_2012_26

View of vegetation in channel. Summer 2018

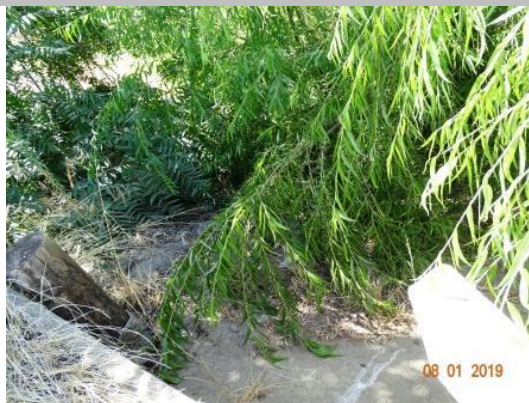
Photo 1 of 1 : CH\_2019\_NA0013\_36\_29\_20190814\_00085.jpg

Rating **	N	Issue No.	29	GPS Lat/Long
Issue Type +	Ma	Location *		37.282060 °
Category	Rivers, Channels & Designated Flood			-120.324870 °
Item	Revetments			
DWR ID	DWR_NA0013_36_c_2012_29			
Action/Comments				
Inspector Comments: The channel is concrete-lined at the bridge.

View of the concrete-lined channel section underneath the bridge.  
Summer 2019

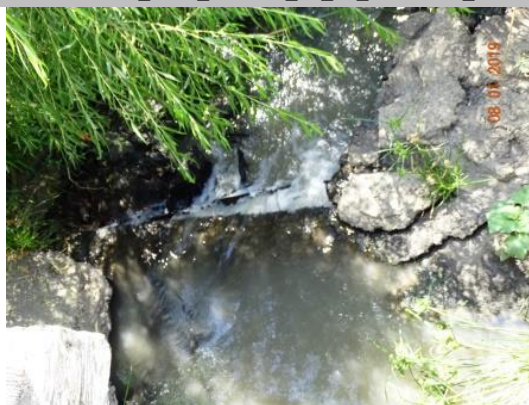
Photo 1 of 1 : CH\_2019\_NA0013\_36\_30\_20190814\_00086.jpg

Rating **	M	Issue No.	30	GPS Lat/Long
Issue Type +	En	Location *		37.282285 °
Category	Rivers, Channels & Designated Flood			-120.324890 °
Item	Encroachments			
DWR ID	DWR_NA0013_36_c_2012_30			
Action/Comments				
Inspector Comments: There is a concrete weir across the creek that does not appear to have a permit.

View looking downstream at concrete weir across channel. Summer 2019

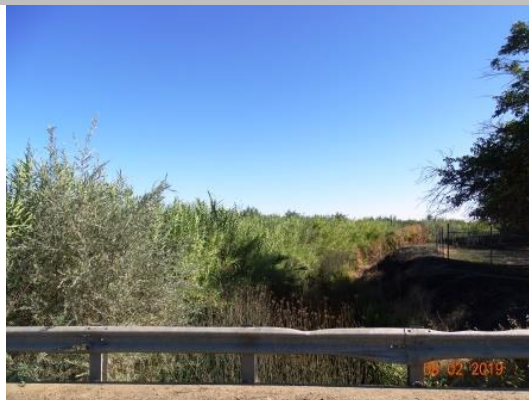
Photo 1 of 3 : CH\_2019\_NA0013\_36\_31\_20190814\_00087.jpg

Inspector Comments: Arundo in the channel should be cleared.

View of vegetation in the channel. Summer 2019

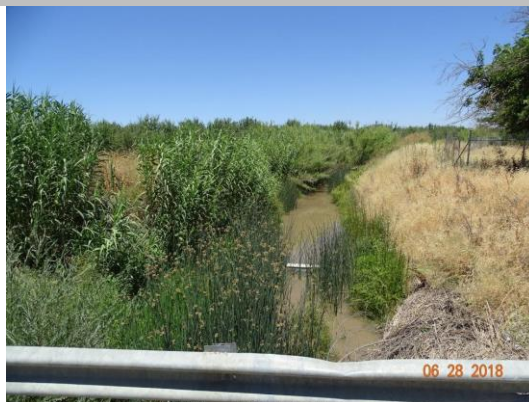
Photo 2 of 3 : CH\_2019\_NA0013\_36\_31\_20190722\_00016.jpg

View of vegetation in the channel. Summer 2018

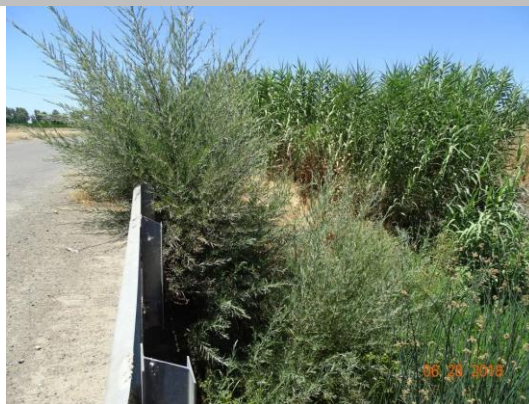
Photo 3 of 3 : CH\_2019\_NA0013\_36\_31\_20190722\_00017.jpg

Rating **	M	Issue No.	31 (cont)	GPS Lat/Long
Issue Type +	Ma	Location *		37.280720 °
Category	Rivers, Channels & Designated Flood			-120.331200 °
Item	Vegetation & Obstructions			
DWR ID	DWR_NA0013_36_c_2012_31			
Action/Comments				
Inspector Comments: Arundo in the channel should be cleared.

View of vegetation growing underneath crossing. Summer 2018

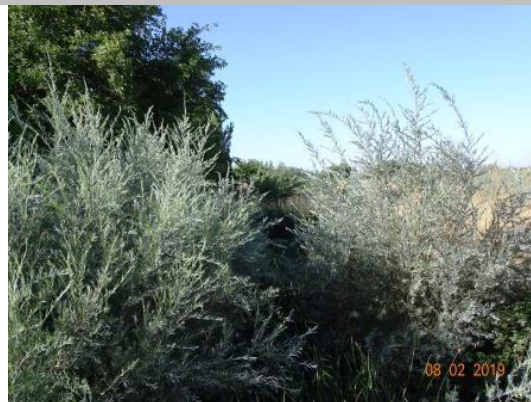
Photo 1 of 2 : CH\_2019\_NA0013\_36\_36\_20190814\_00088.jpg

Rating **	M	Issue No.	36	GPS Lat/Long
Issue Type +	Ma	Location *		37.280720 °
Category	Rivers, Channels & Designated Flood			-120.331200 °
Item	Vegetation & Obstructions			
DWR ID	DWR_NA0013_36_c_2012_36			
Action/Comments				
Inspector Comments: Vegetation may impede flow and needs to be cleared.

View of vegetation in the channel. Summer 2019

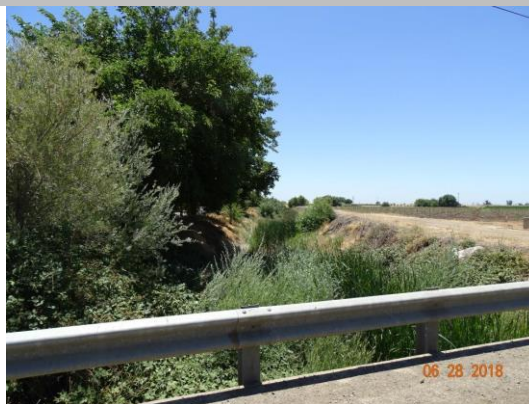
Photo 2 of 2 : CH\_2019\_NA0013\_36\_36\_20190722\_00019.jpg

Rating **	M	Issue No.	36 (cont)	GPS Lat/Long
Issue Type +	Ma	Location *		37.280720 °
Category	Rivers, Channels & Designated Flood			-120.331200 °
Item	Vegetation & Obstructions			
DWR ID	DWR_NA0013_36_c_2012_36			
Action/Comments				
Inspector Comments: Vegetation may impede flow and needs to be cleared.

View of vegetation in the channel. Summer 2018
